Research Report
KTC-90-24

EVALUATION OF FLEXIBLE
DELINEATOR POSTS

Kentucky Transportation Center
College of Engineering
University of Kentucky

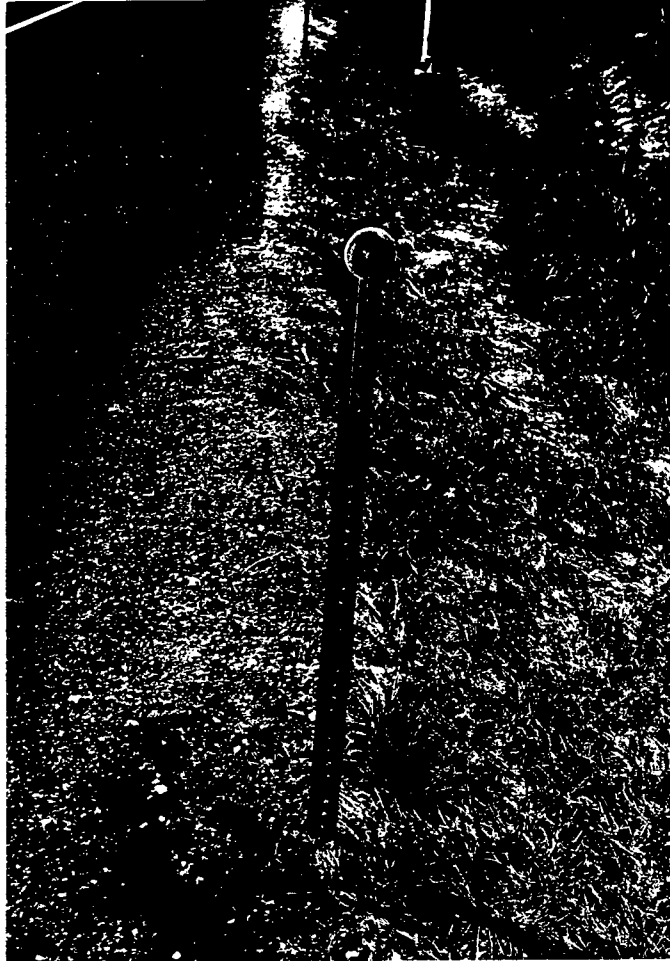
Figure 1. Standard Lightweight Metal Post.

1. standard lightweight metal post as specified by the Kentucky Department of Highways (Figure 1),
2. "Roadmarker" CRM-375 flexible post manufactured by Carsonite International (Figure 2),
3. "Curv-Flex" CFRM-400 flexible post manufactured by Carsonite International (Figure 3), and
4. "Safe-Hit" flexible post manufactured by Safe-Hit Corporation (Figure 4).

A three-inch circular delineator unit was bolted to the metal post to provide reflectivity while the flexible posts used reflective sheeting that was attached to the post.

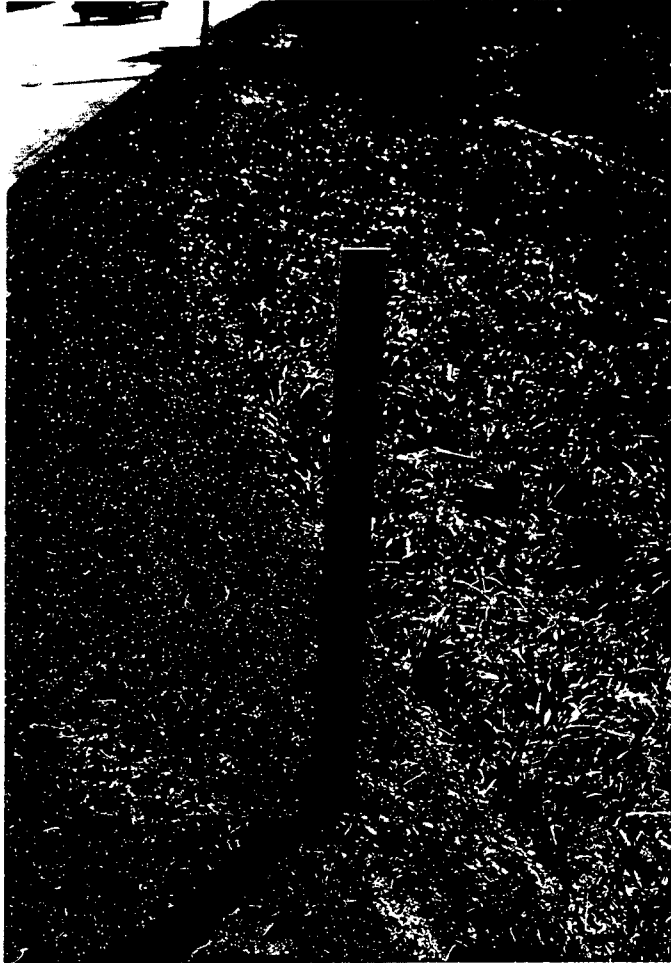
Figure 2. "Roadmarker" CRM-375 Flexible Post.

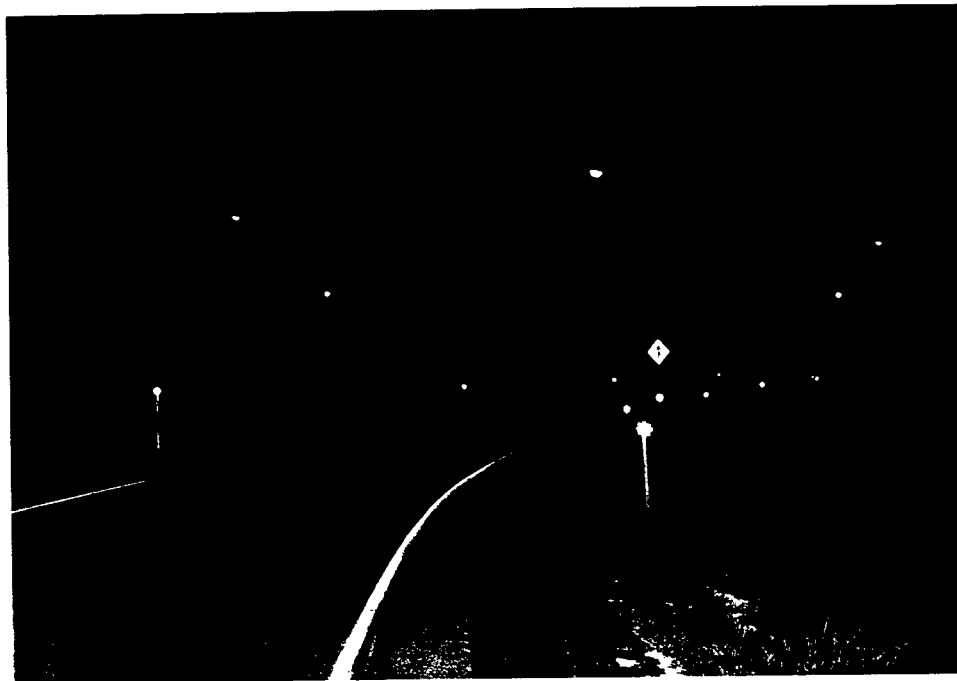
Figure 5. Daytime and Nighttime Photographs of New Installation of Standard Lightweight Metal Posts (Ramp from I 64 EB to US 127 NB).

Daytime and nighttime photographs of the new installations of the four types of delineator posts are shown in Figures 5 through 8. Each of these installations were on ramps.

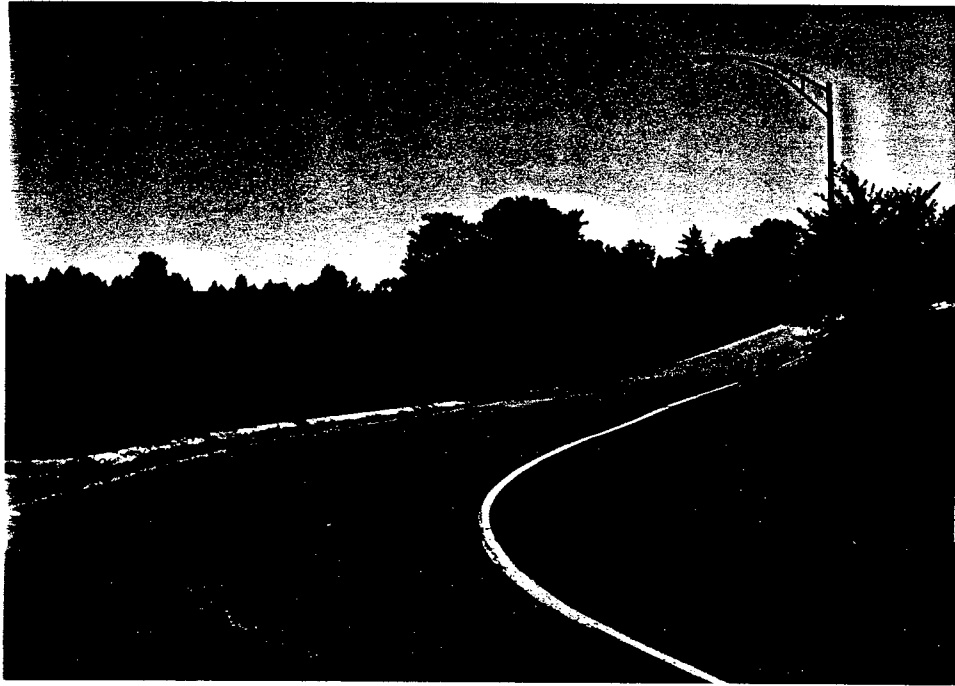
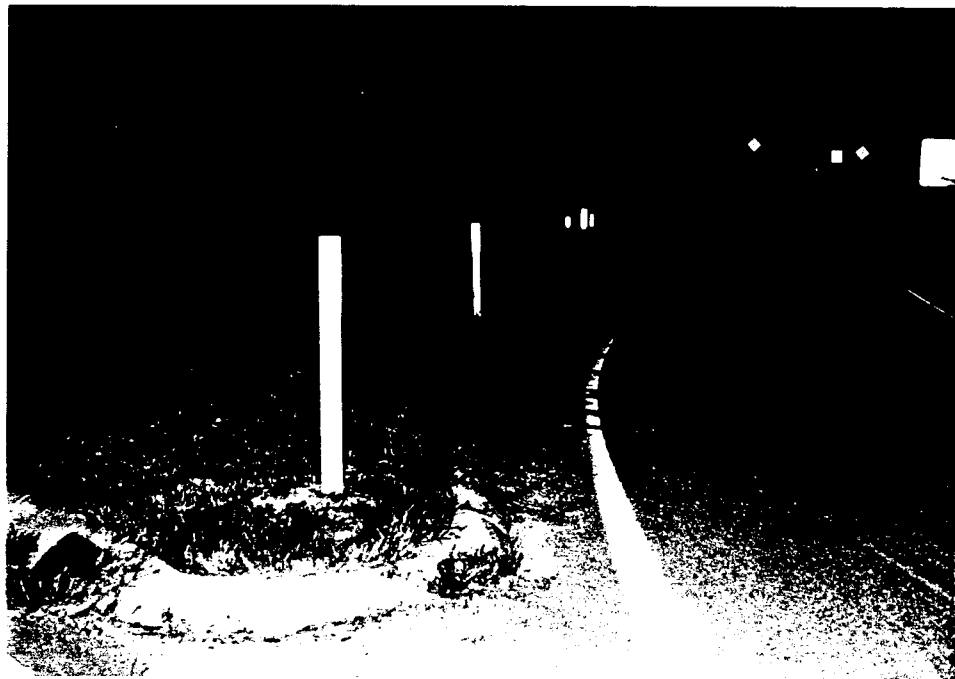
Figure 6. Daytime and Nighttime Photographs of New Installation of "Roadmarker" CRM-375 Flexible Posts (Ramp from KY 151 to I 64 WB).

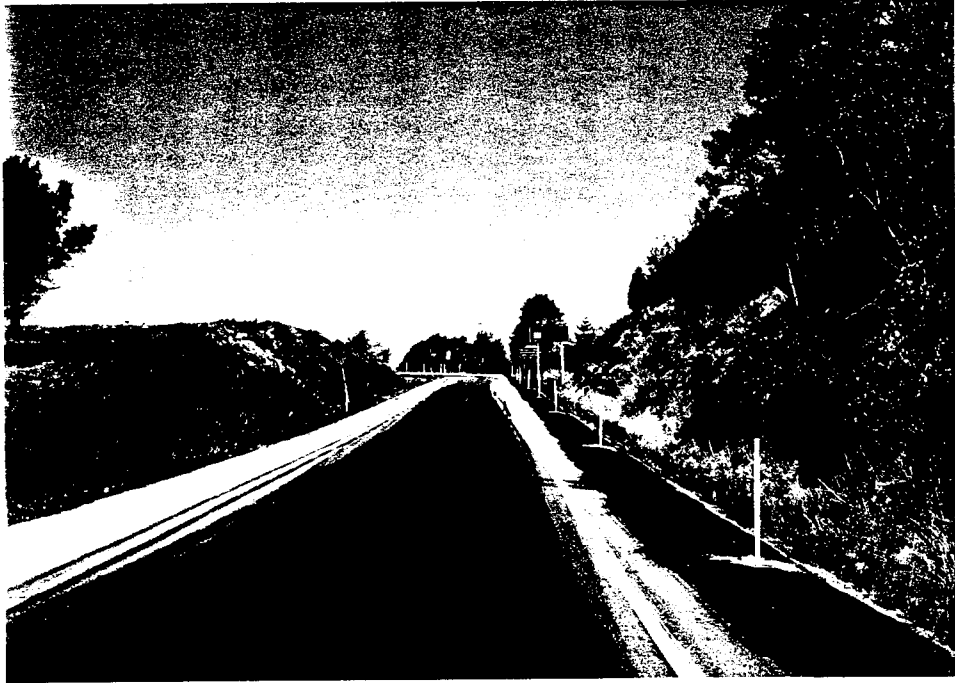
Figure 8. Daytime and Nighttime Photographs of New Installation of "Safe-Hit" Flexible Posts (Ramp from I 64 WB to KY 395).

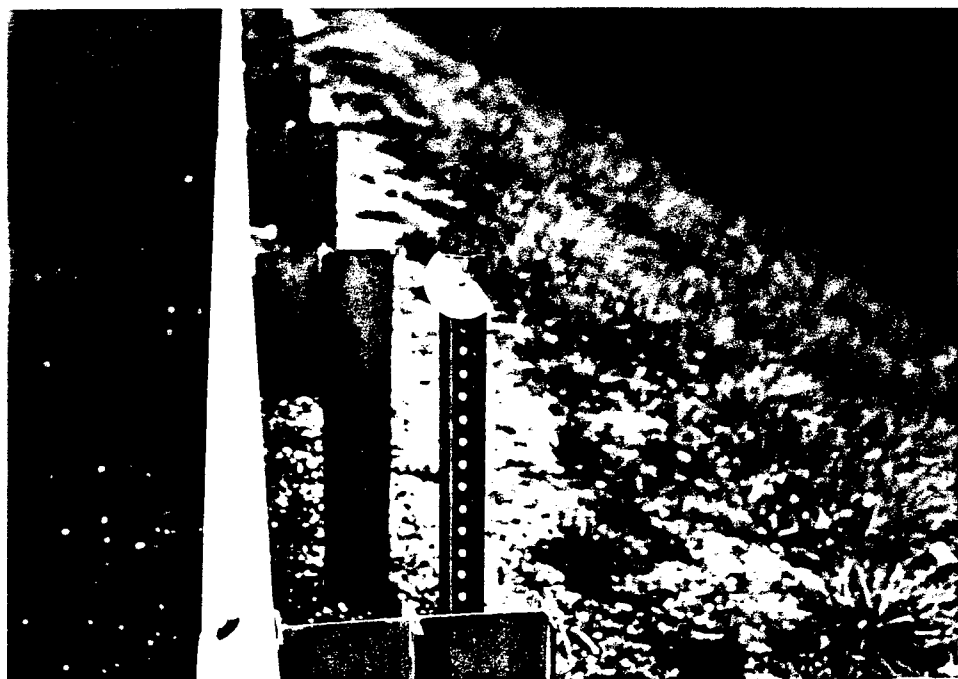
Figure 9. Damage to Delineator on Metal Post.

There was also a number of metal posts that had missing or damaged delineators. The survey conducted after two years in service revealed that 22 percent of the metal posts either had no delineator or a substantial portion of the delineator was missing (Figure 9). Considering the percentage of ineffective delineators on the posts, the percentage of the original installation of metal posts remaining that had effective delineators would be lowered to 61 percent. As a result of a previous evaluation (1), a recommendation had been made to discontinue use of plastic-backed delineators. However, both metal-backed and plastic-backed delineators were noted during the inspections.

When metal posts are used, the circular delineator units attached to the posts should have a metal backing. The use of plastic-backed delineators should be discontinued.

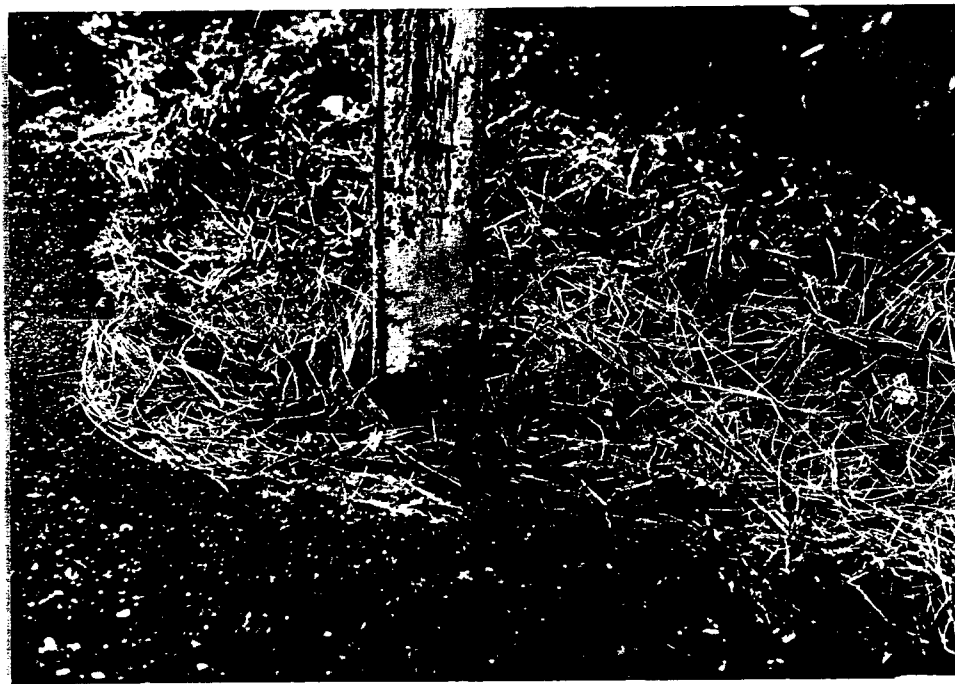
Figure 10. Failure of Base of Flexible Post.

The survey conducted after two years in service revealed that several of the few remaining flexible posts were damaged. The damage typically consisted of either: 1) the base partially split allowing the post to bend with the wind or fall to the ground (Figure 10) or 2) the top damaged from mowing (Figure 11). It was noted during the inspections that several of the Carsonite posts failed by splitting at the base at ground level.

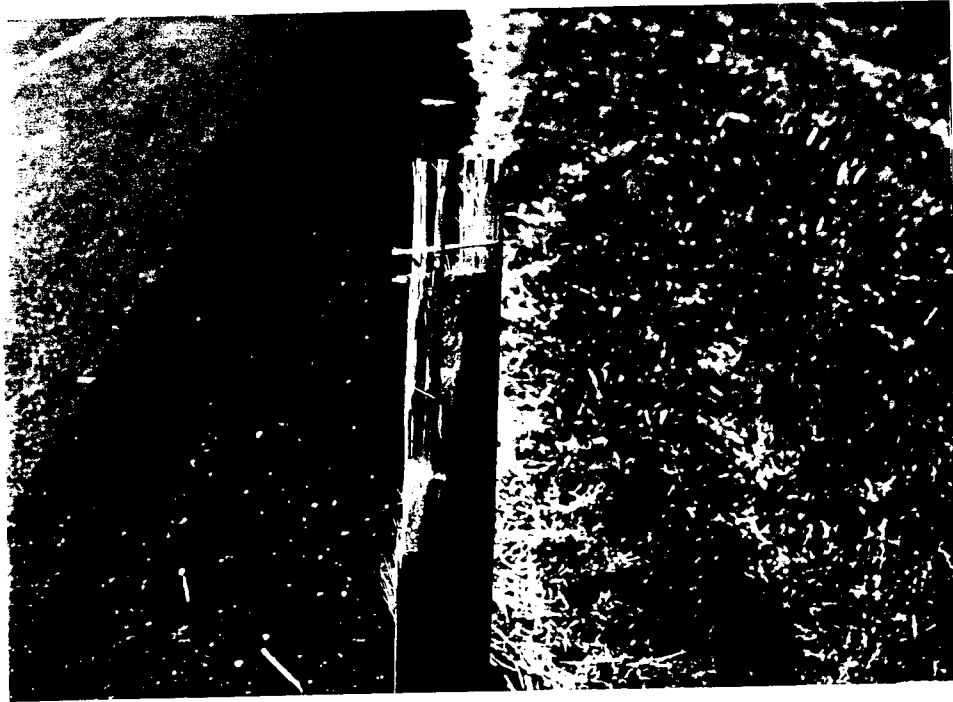
Figure 11. Mowing Damage to Flexible Post.

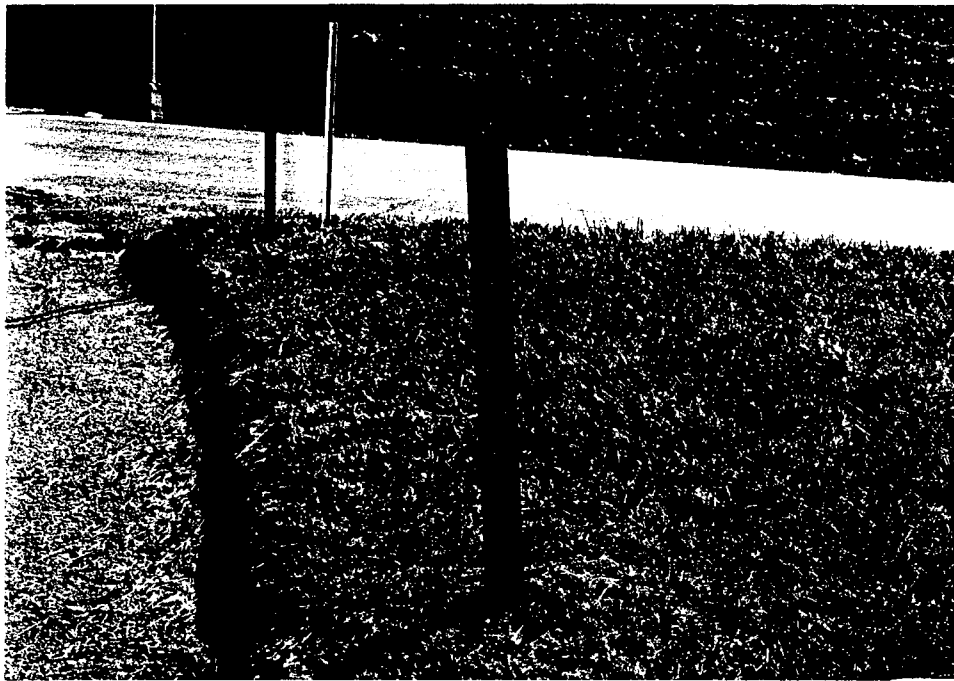
Figure 12. Flexible Post in Good Condition after Two Years in Service.

The flexible posts that remained after two years in service could still be run over and would rebound. Only two of the eight remaining Carsonite CRM-375 posts were still in good condition. Six of the 14 remaining Carsonite CRM-400 posts were in good condition (Figure 12). The single remaining Safe-hit was in good condition.
